, FRACTOGRAPHY OF RIM POLYCARBAMATE

MATERIALS,

Thesis

The School of Engineering of the
UNIVERSITY OF DAYTON

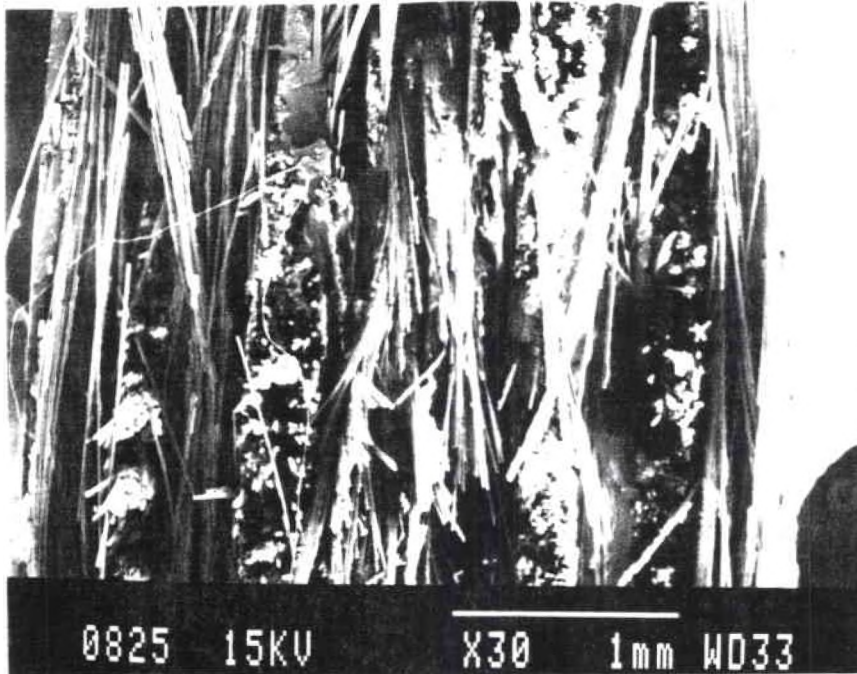
Figure 19. Fiber pullout, RIM tension specimen, (x 30).

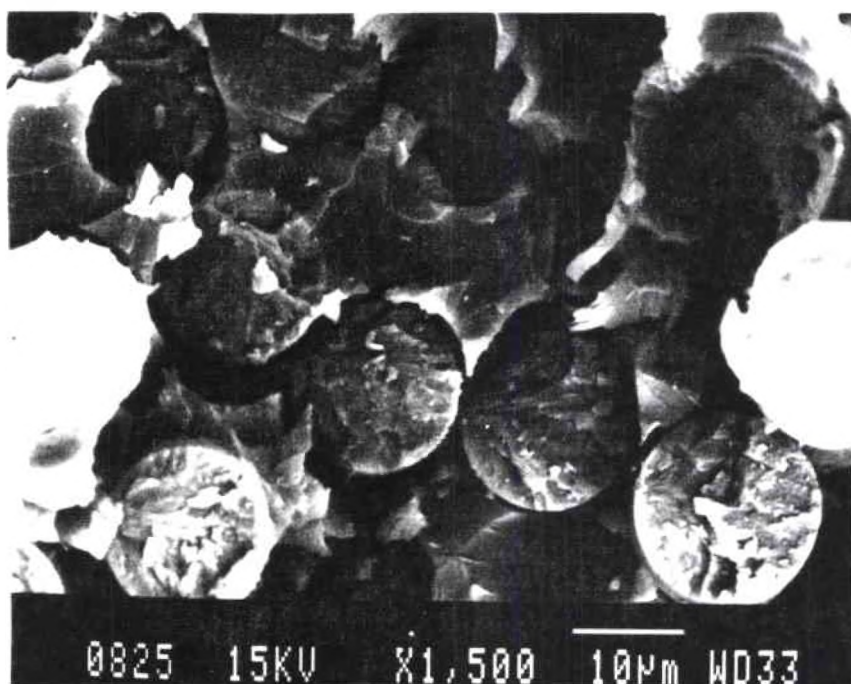
Figure 22. Radial patterns on fractured fibers of RIM tension specimen(x1500).

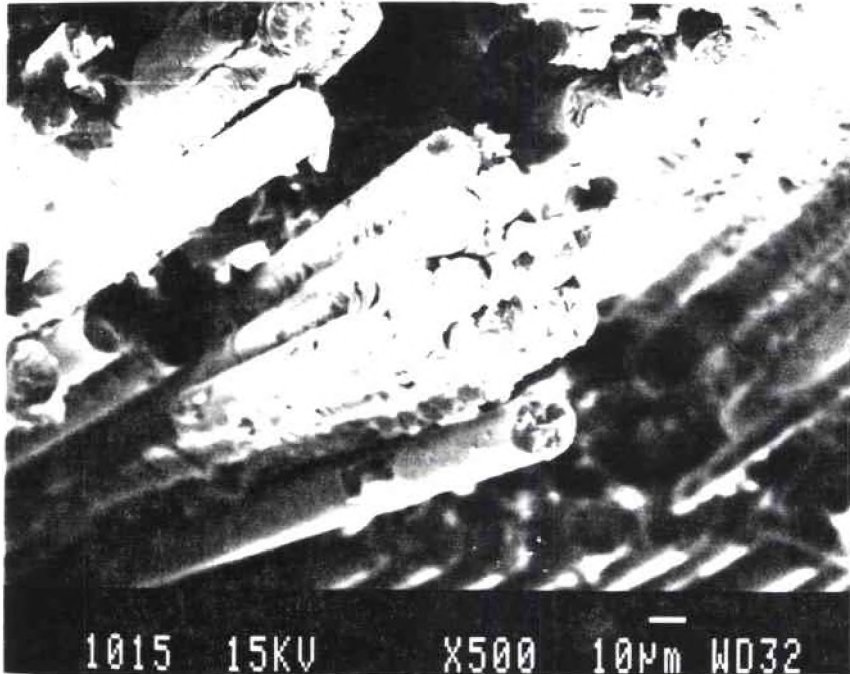
A characteristic of the aged tensile specimens was some increase in fiber-matrix adhesion when compared with the unaged specimens. Figure 23 illustrates fiber bundles with matrix adhering to them. This effect was observed more in the specimens that underwent longer aging times, but no difference in adhesion was noted due to the different aging temperatures. After aging of one week, the increase

Figure 23. Matrix adhesion to fiber bundles on tension specimen (x500).

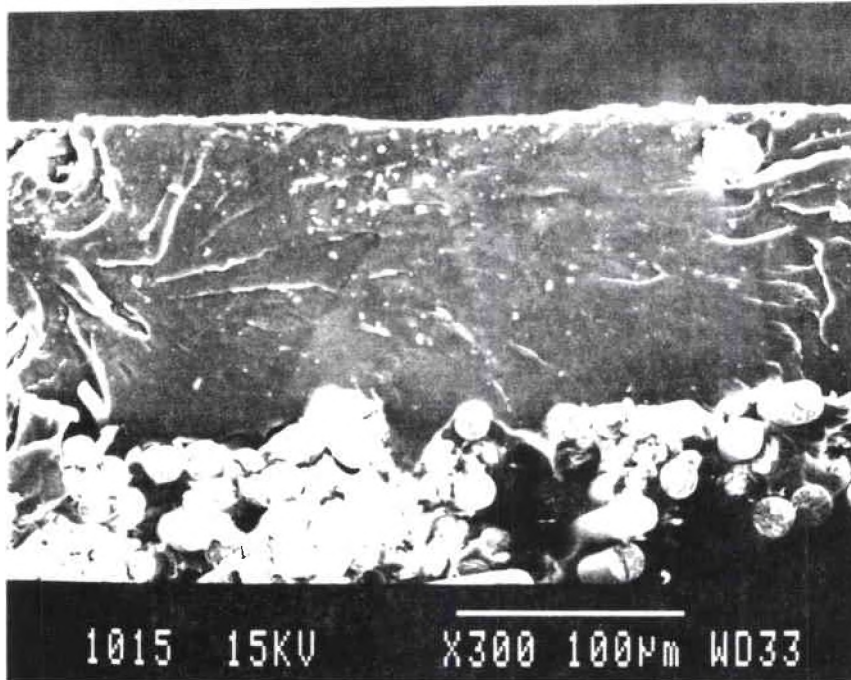
in fiber-matrix adhesion was noted. In addition, the surface where the fibers had pulled out, appeared to be much rougher as a consequence of the increase in bonding. Also, the increase in ultimate tensile strength measured from the mechanical testing of the aged specimens corresponds with the idea that better bonding was achieved in the thermally-aged specimens. River patterns on fractured matrix surfaces as well as radials on the tips occur in the aged specimens. Figures 24 and 25 illustrate these features.

Figure 24. Radials in fiber tips as well as river patterns on matrix areas, tension specimen (x300).

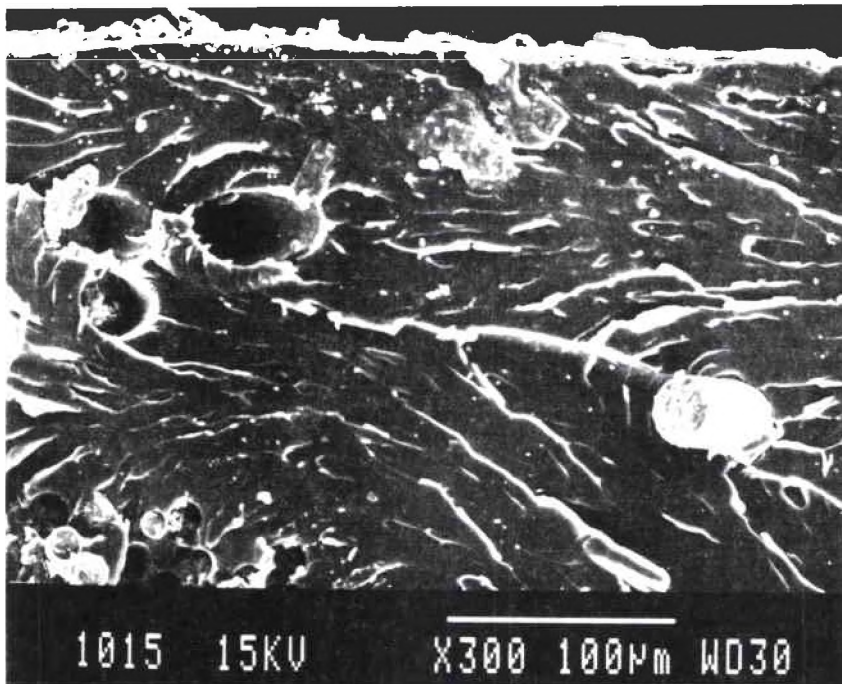
Figure 25. River patterns on matrix fracture surface and fiber pullout on tension specimen (x300).

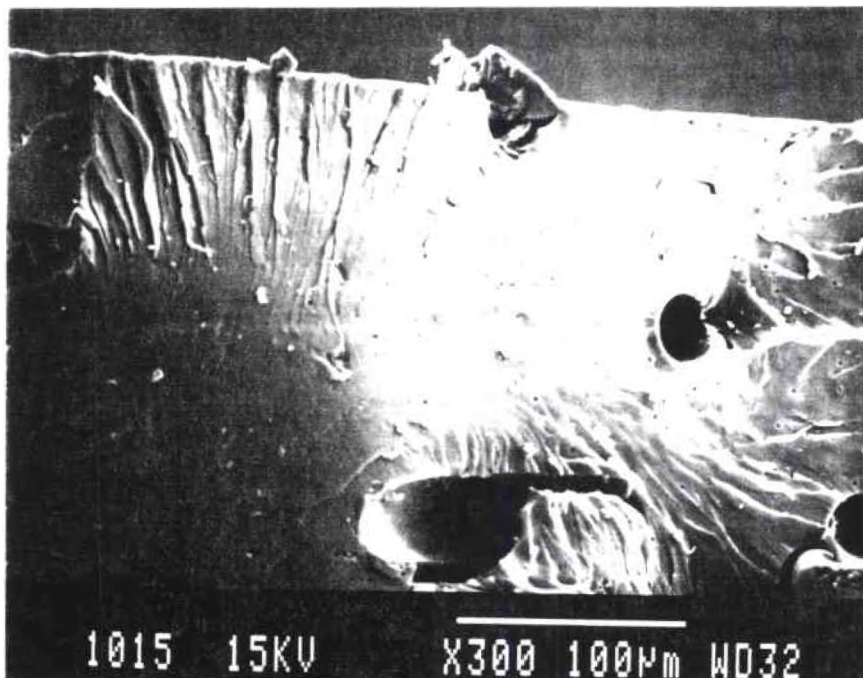
Figure 26. Fiber pullout and matrix cracking on tension specimen (x300).

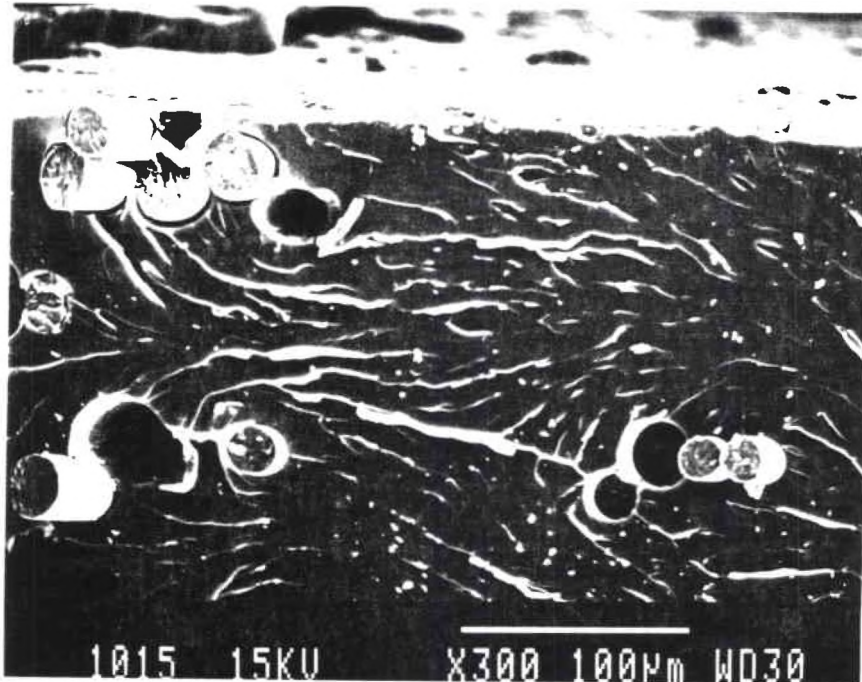
increased moisture functioning as a plasticizer. Figures 27 through 29 show the various features observed on the fracture surfaces of the humidity-aged specimens.

Figure 27. River patterns and fiber pullout on tension specimen (x300).

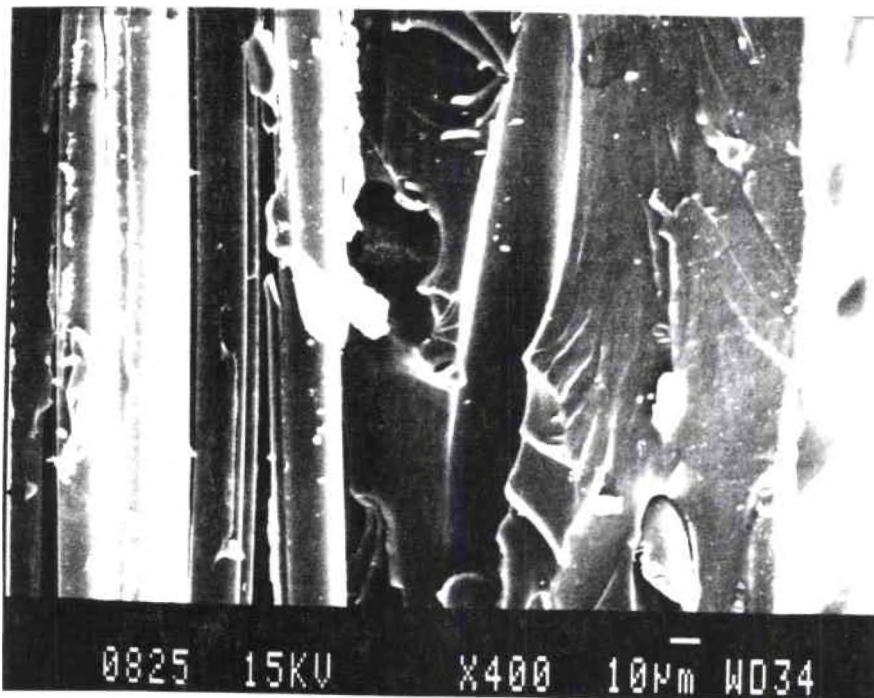
Figure 28. Smooth surfaces on matrix channels on humidity-aged tension specimen (x400).

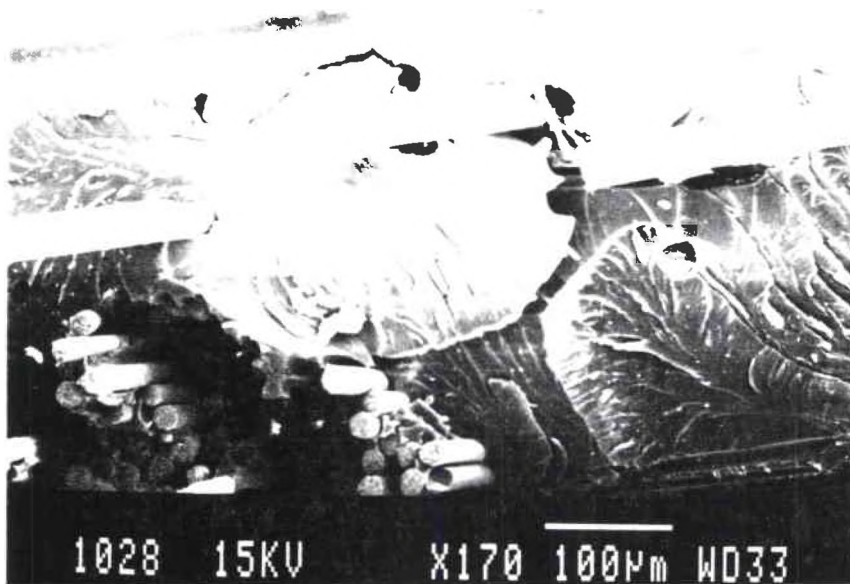
Figure 29. Matrix cracking and debris, tension humidity-aged specimen (x170).

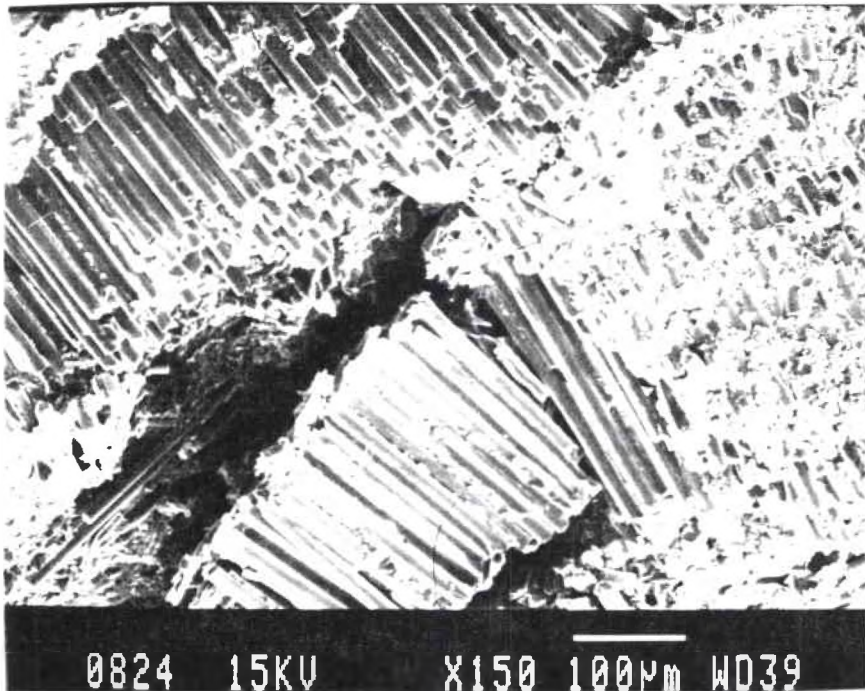
Figure 32. Microbuckling of fibers, unaged compression specimen.

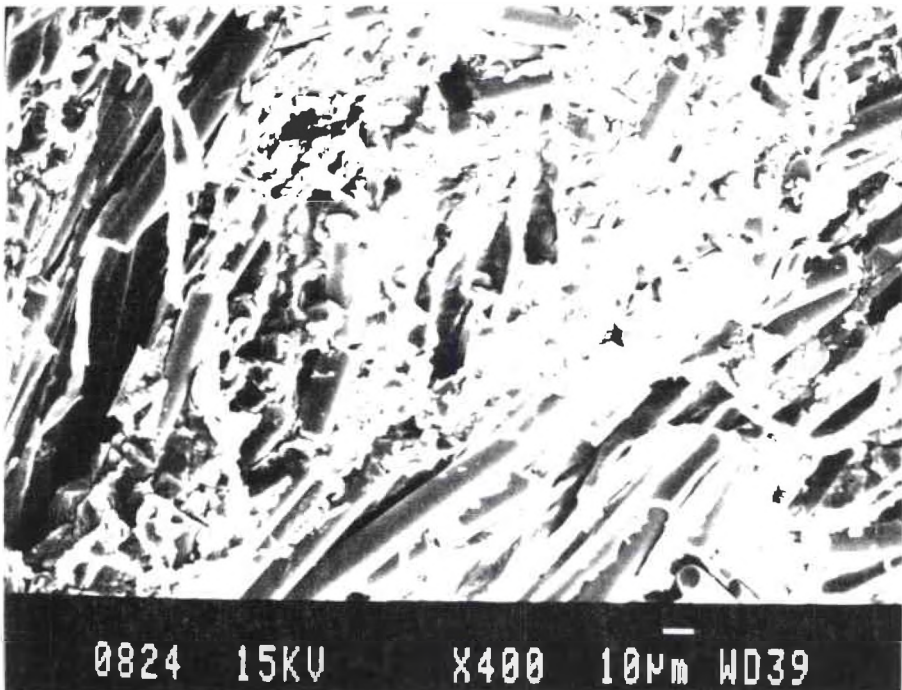
Figure 33. Broken fibers and fracture debris, unaged compression specimen.

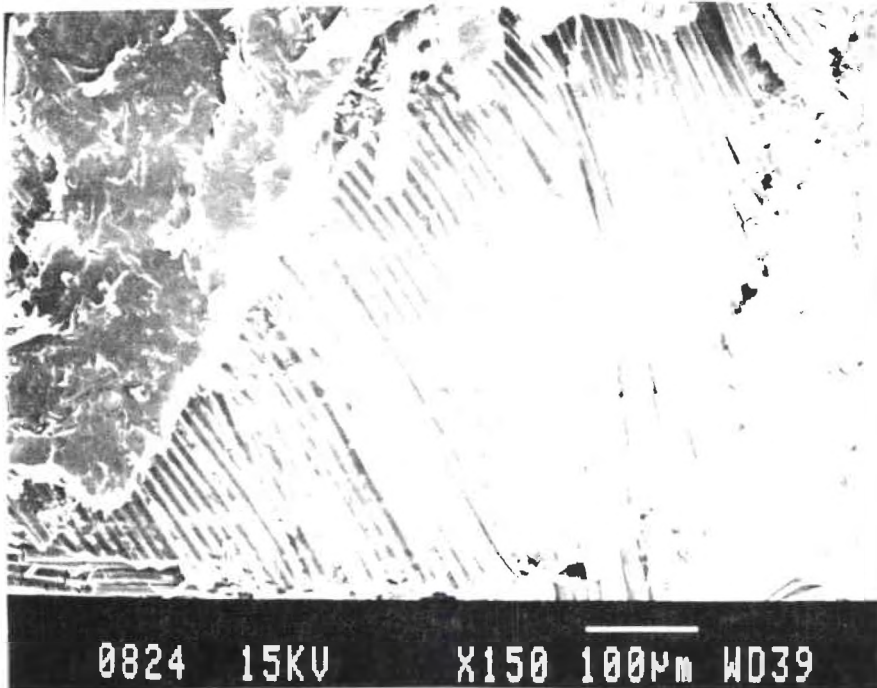
Figure 34. Matrix cracking and broken fibers on an unaged compression specimen (x150).

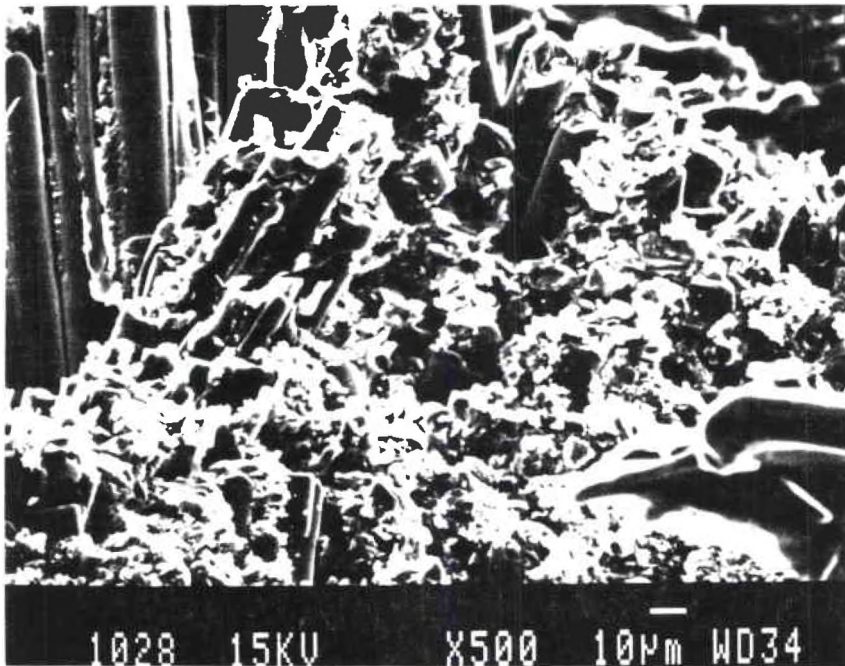
Figure 35. Matrix cracking and debris as well as fiber cracking, unaged compression specimen (x500).

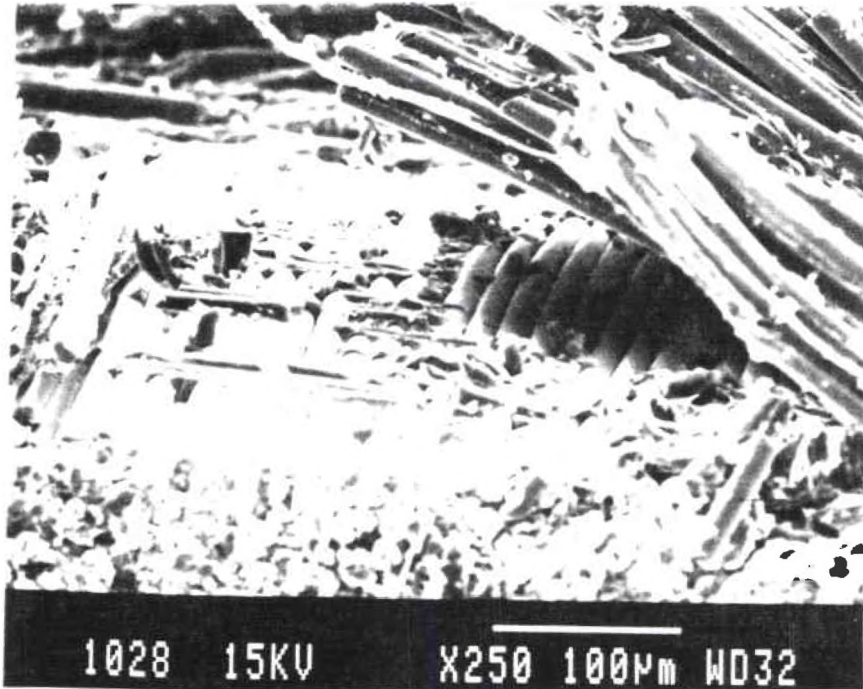
Figure 36. Bent fibers and severe fiber and matrix cracking, unaged compression specimen (x250).

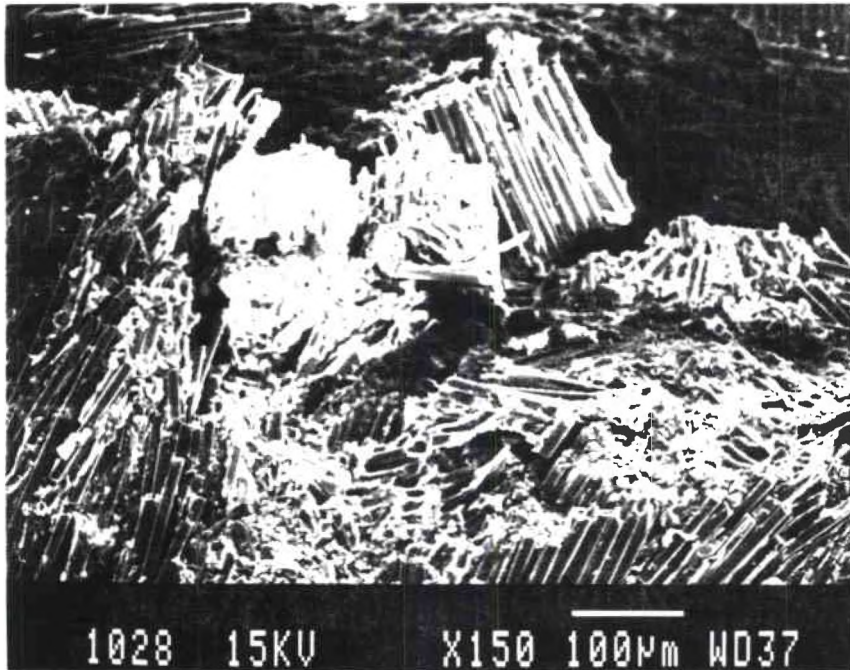
Figure 37. General overview of a thermally-aged compression specimen (x150).

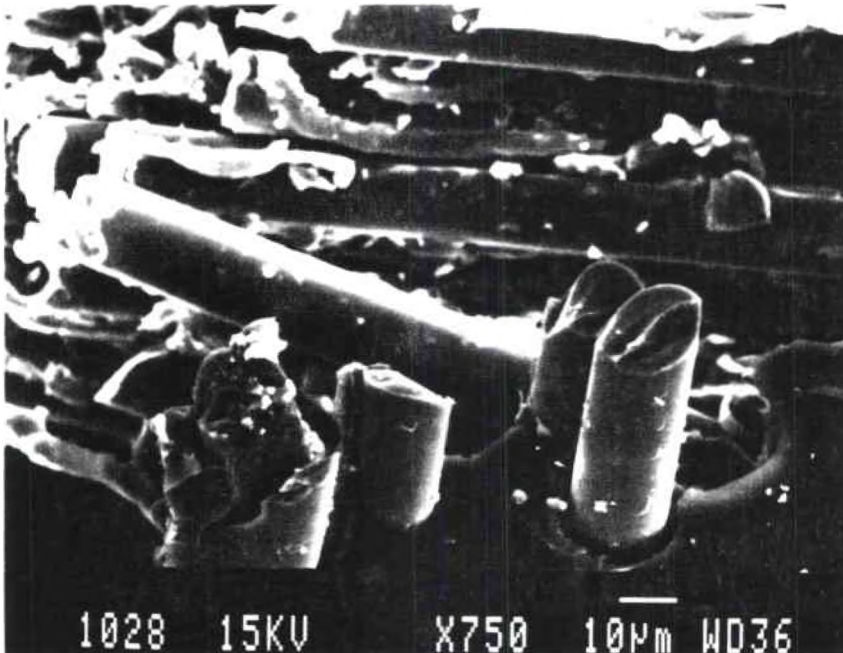
Figure 38. Fiber tip chop marks and matrix cracking debris, compression thermally-aged specimen (x750).

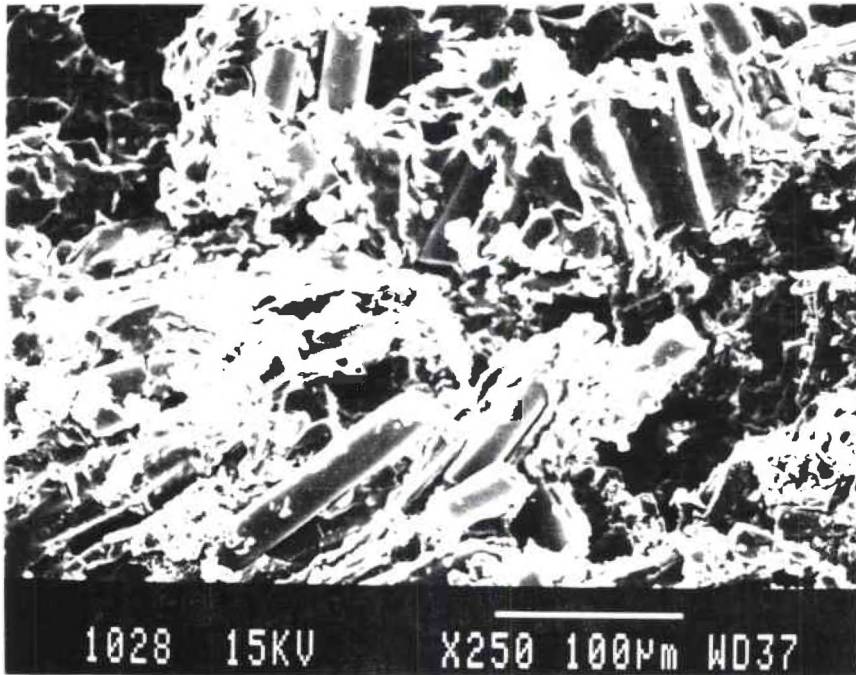
Figure 39. Severe matrix cracking and broken fibers on a humidity-aged compression specimen (x250).

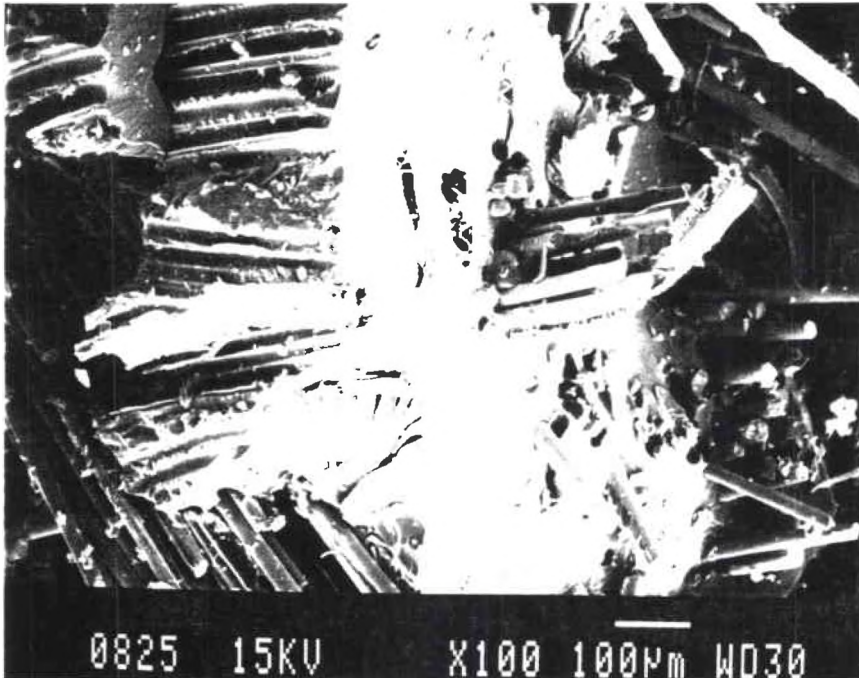
Figure 42. Fiber pullout, matrix cracking and matrix-fiber debonding (x100).

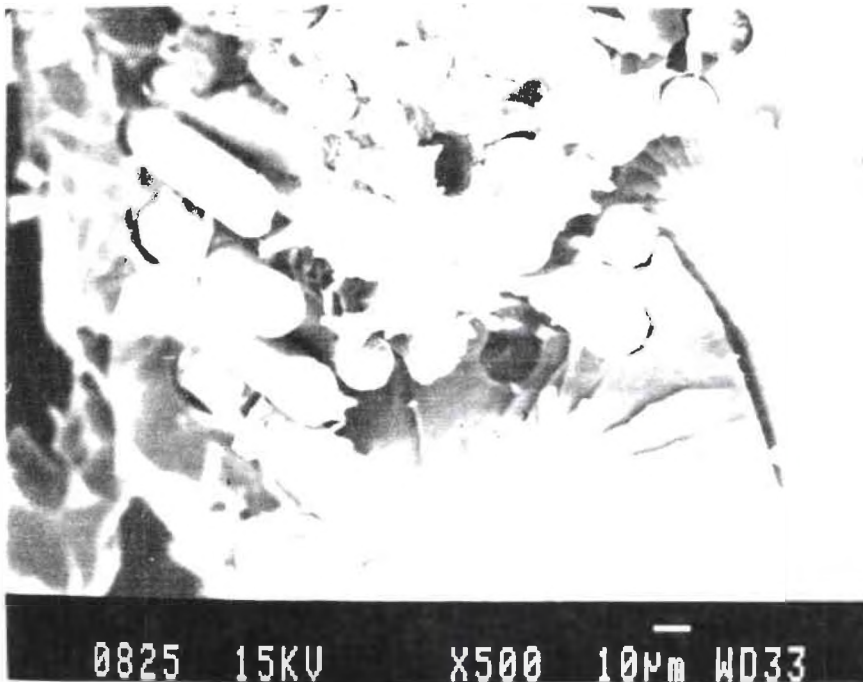
Figure 43. Fiber bundle on the compressive side of a flexure specimen (x500).

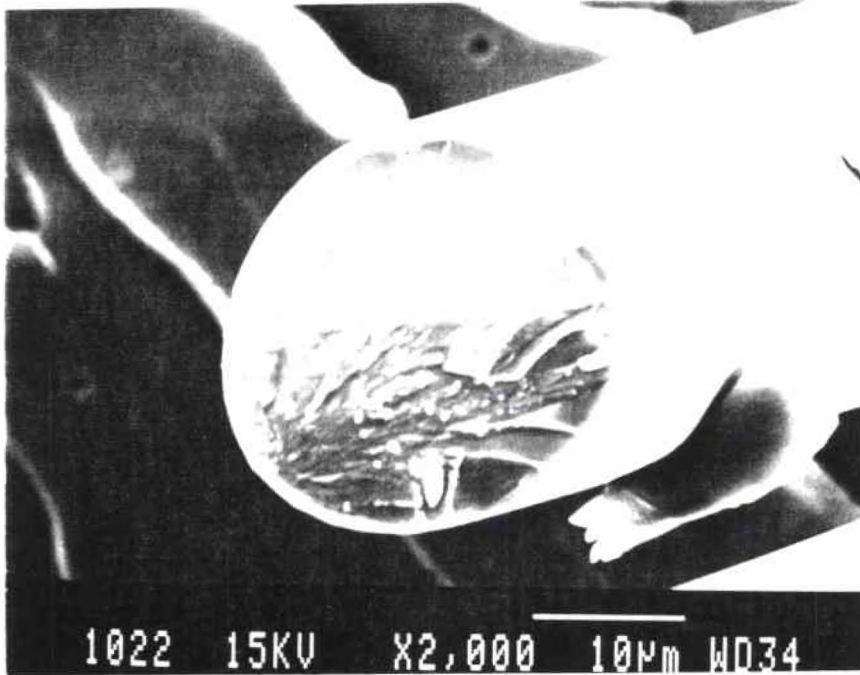
An increase in the fiber-matrix adhesion is a characteristic of the flexure specimens. Figure 47 shows the radials on the fracture surface of a fiber on the tension side of a flexure specimen aged at 180 °F for one week. Figure 48 illustrates a fiber from the compression side of the same flexure specimen, where chop marks appeared to be characteristic of the fiber fracture surface. River patterns on the matrix fracture surface and some void areas are shown in Figure 49. Some bent fibers with a small amount of fiber-matrix adhesion are seen in Figure 50 at the center area of the aged flexure specimen. Hackles normal to the fiber direction as seen in Figure 51 have been observed in the compression side of an aged specimen. In Figure 52 the large amount of matrix adhering to the fiber indicates the increase in fiber-matrix adhesion when the specimen has been aged for 1 month at 250 °F. Chop marks characteristic of compression failures were seen on the fractured fibers on the compression side of a flexure specimen (Figures 53 and 54). Debris in the center area of a flexure specimen aged at 250 °F for one week and is documented in Figure 55. Bent fibers, matrix cracking and debris are illustrated in Figures 56 and 57, both taken from the compression sides of specimens aged at 250 °F and 180 °F for 1 week, respectively. No major differences have been noted between specimens aged for a week or

Figure 47. Radials on the tensile side fiber of a thermally-aged flexure specimen (x2000).

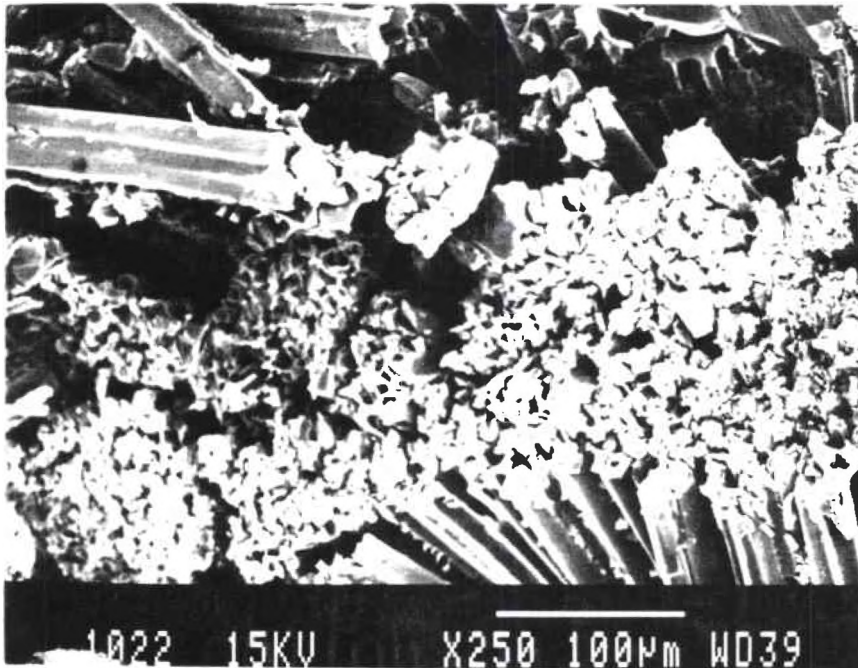
Figure 56. Bent fibers, matrix cracking, and debris on compressive side of thermally-aged flexure specimen (x250).

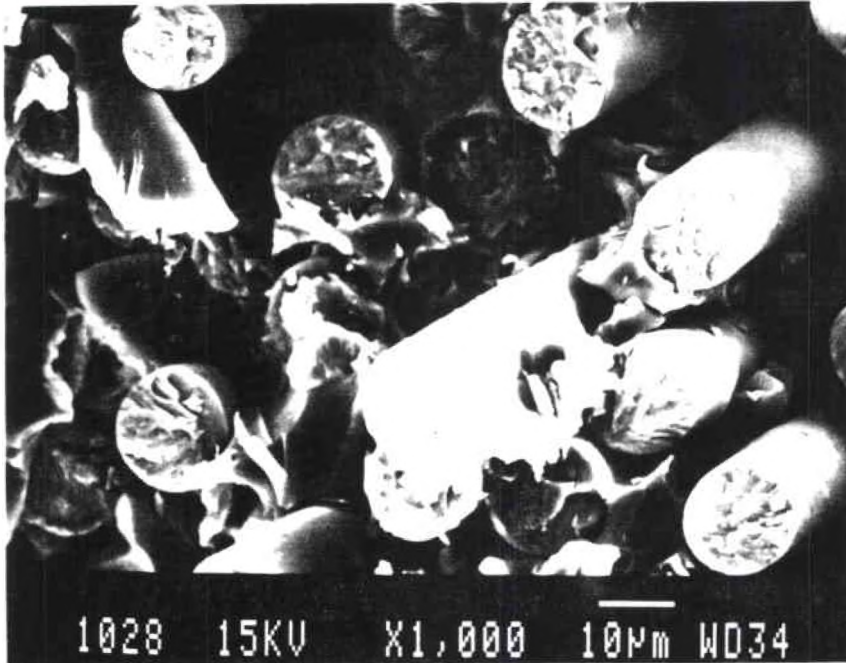
Figure 60. Radials on the fiber tips of a humidity-aged flexure specimen tensile side (x1000).

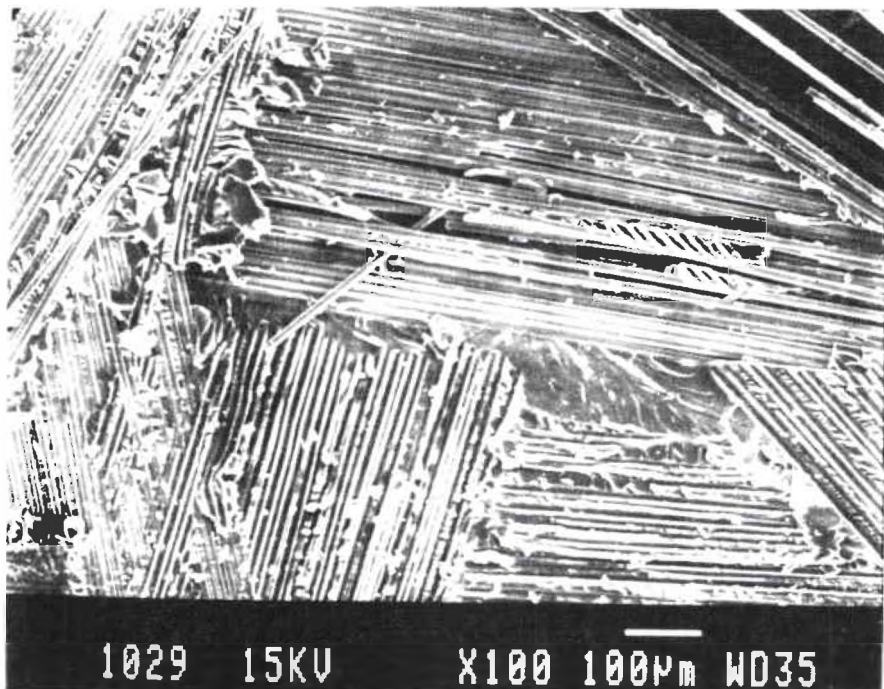
Figure 64. Matrix cracking and fiber pullout on an unaged shear specimen (x100).

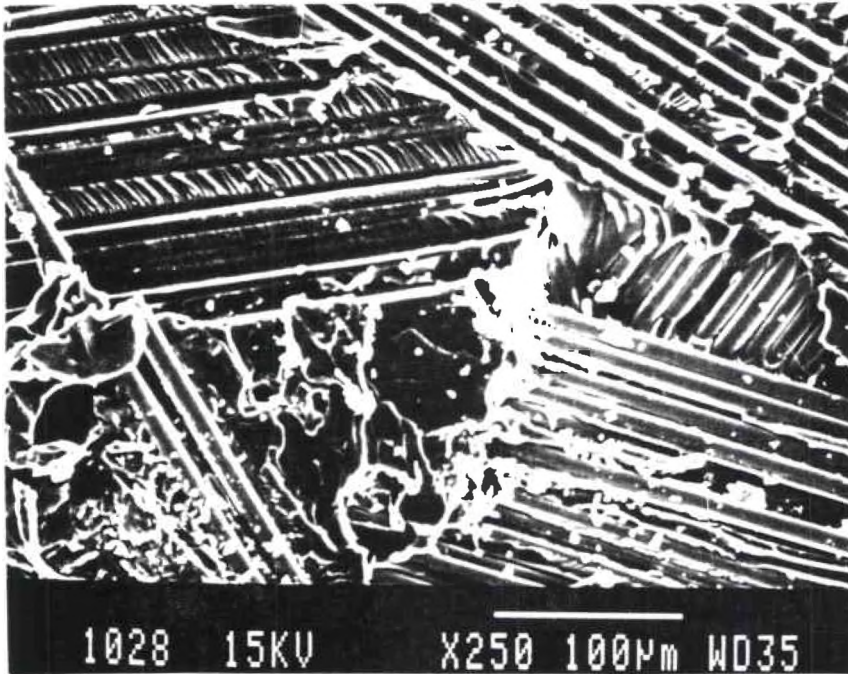
Figure 65. Hackles and matrix cracking, unaged shear specimen (x250).

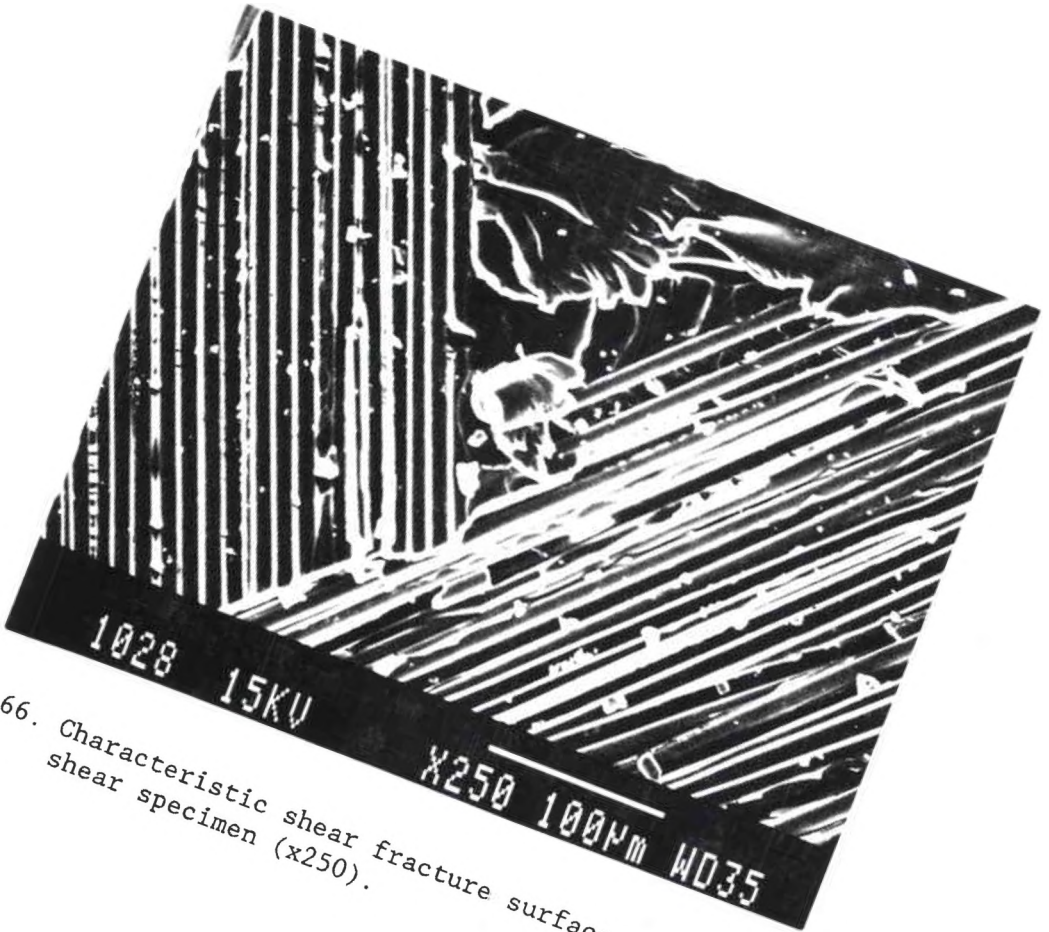
Figure 66. Characteristic shear fracture surface of thermally-aged shear specimen (x250).

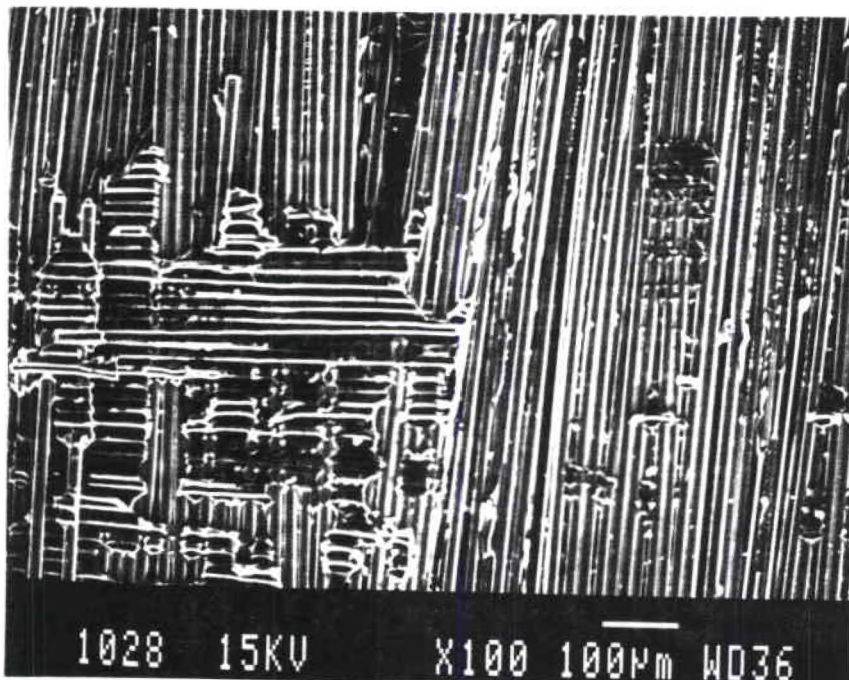
Figure 68. Fiber pullout, hackles, and fiber-matrix debonding (x100).

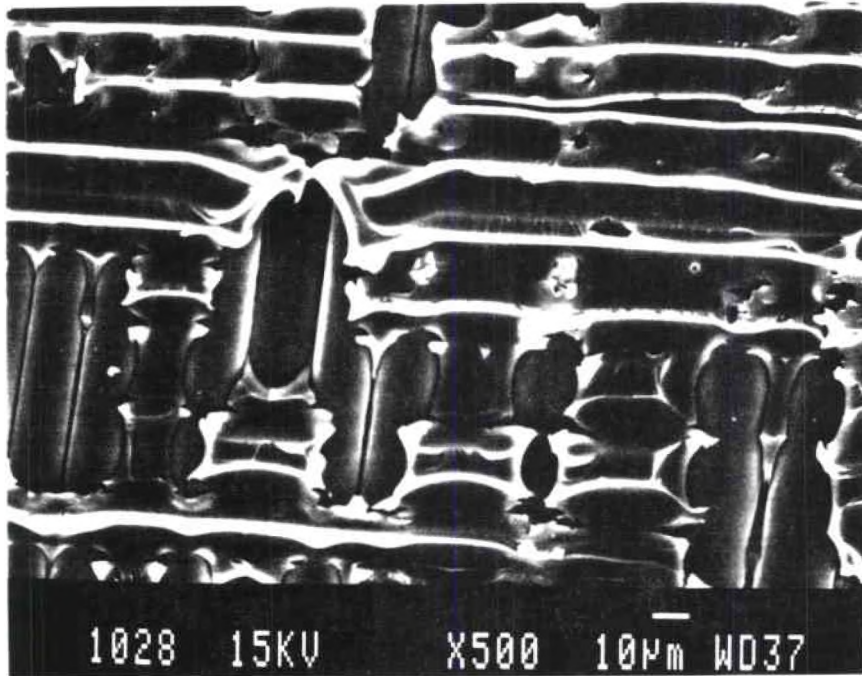
Figure 69. Smooth matrix channels, humidity-aged shear specimen (x500).

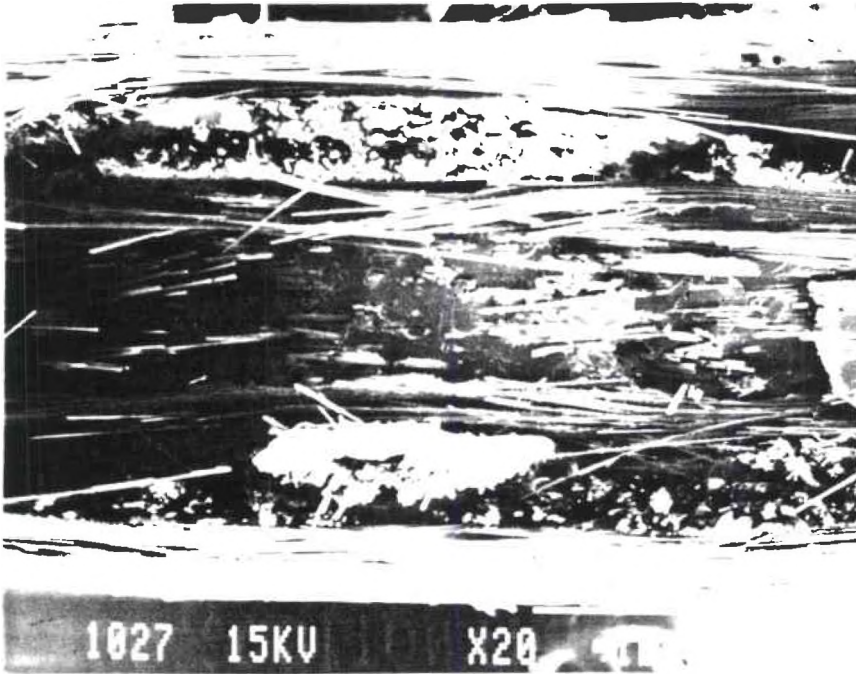
Figure 71. Tension-compression fatigue specimen (x20).

A general overview of the fatigue fracture surface is presented in Figure 71. Already at low magnification matrix debris can be observed. Figure 72 illustrates the presence of river patterns in the matrix surrounding holes resulting from fiber pullout. Unusually high concentrations of porosity are illustrated in Figure 73, as well as

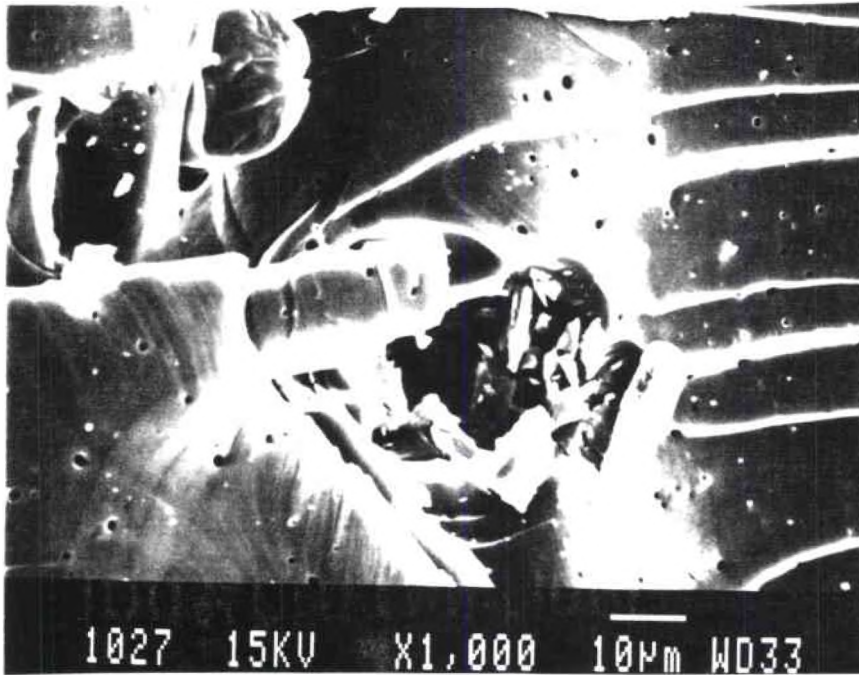
Figure 73. Tension-compression fatigue specimen (x1000).

matrix cracking and debris. Hackles in the matrix are illustrated in Figure 74.
